Observational Study of Final Cleaning and AHERA (Asbestos Hazard Emergency Response Act) Clearance Sampling at Asbestos-Abatement Sites in New Jersey

PEI Associates, Inc., Cincinnati, OH

Environmental Protection Agency, Cincinnati, OH

Aug 89

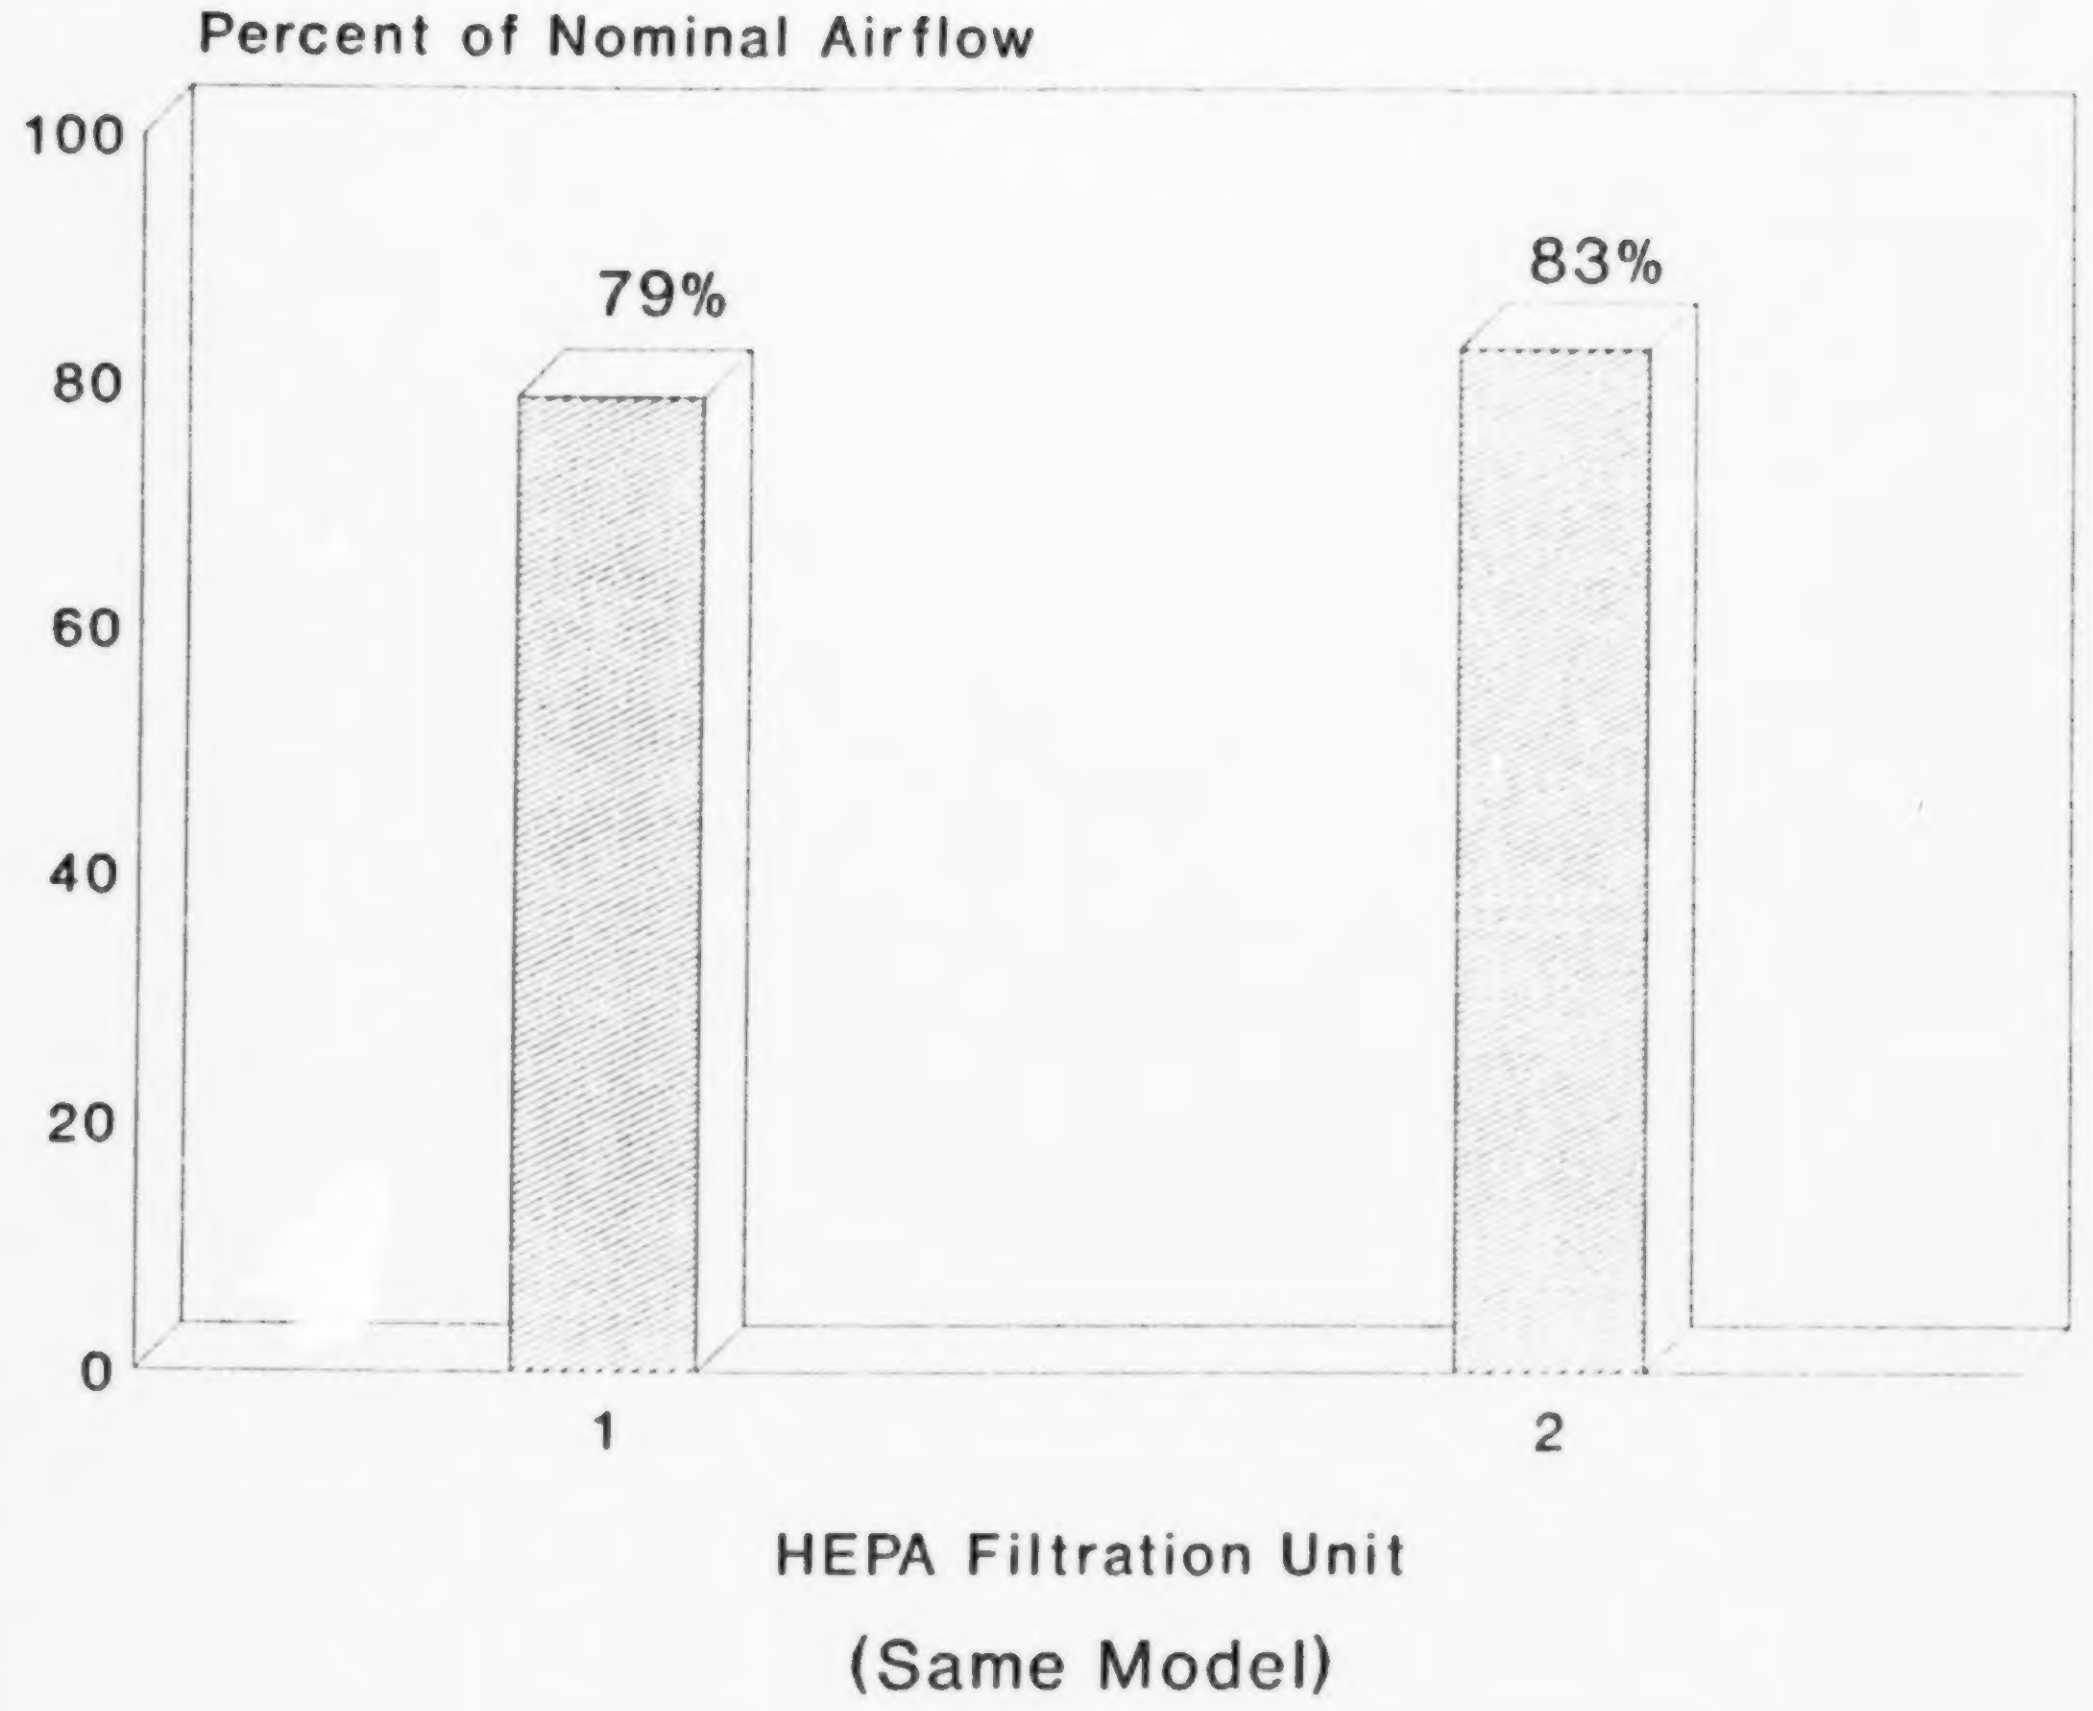
Figure T-1. Airflow performance for HEPA filtration systems operating during final cleanup.

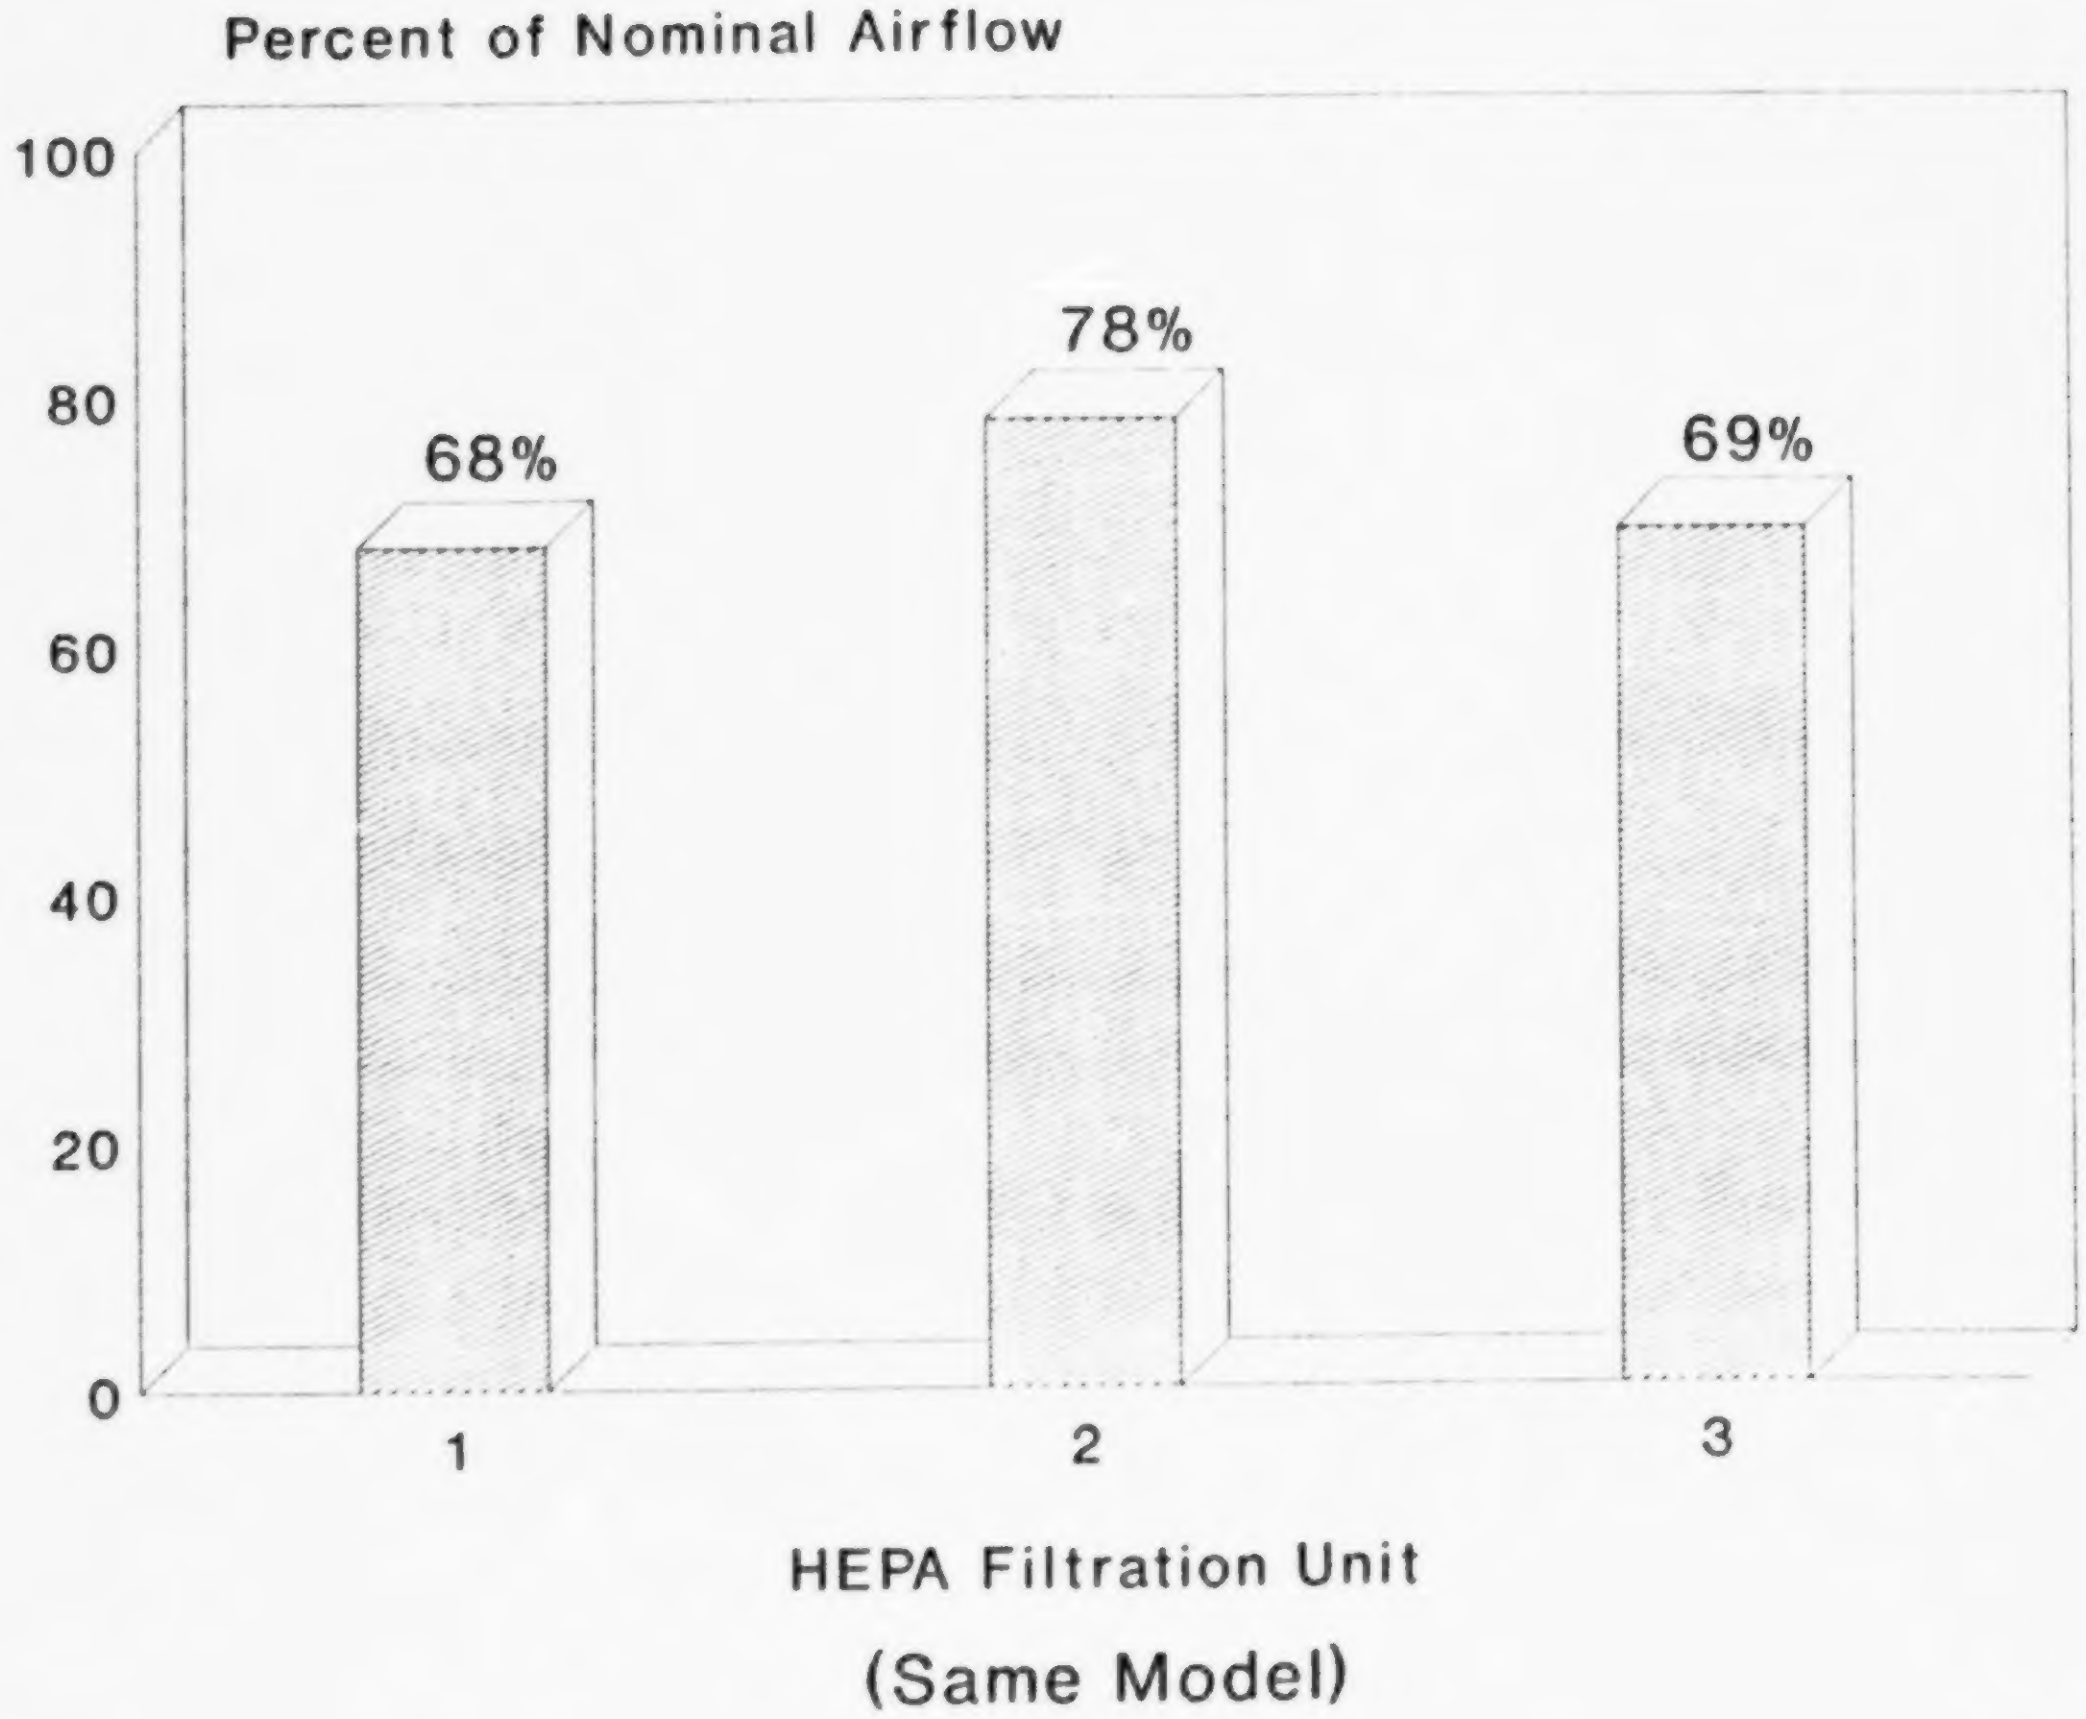
Figure T-2. Airflow performance for HEPA filtration systems operating during AHERA clearance.
